FLYER TO THE LEISURE INDUSTRY

Loss of the yacht *Cheeki Rafiki* and its four crew

Marine Accident Investigation Branch
April 2015

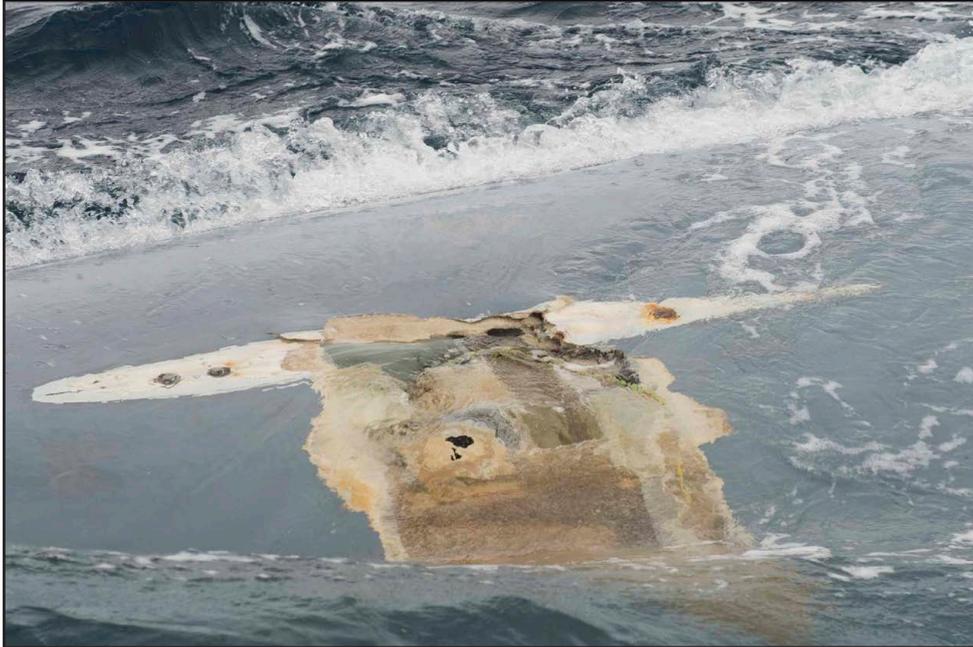
On 16 May 2014, an alert was received from the personal locator beacon of the skipper of the United Kingdom (UK) registered yacht *Cheeki Rafiki*, which was on passage from Antigua to the UK, and located approximately 720 miles east-south-east of Nova Scotia, Canada. Despite a major search effort, during which the yacht's upturned hull was located but not recovered, *Cheeki Rafiki's* four crew remain missing.

In the absence of survivors and material evidence, the causes of the accident remain a matter of some speculation. However it is concluded that the yacht capsized and inverted following a detachment of its keel. In the absence of any apparent damage to its hull or rudder other than that likely to have been directly associated with keel detachment, it is concluded unlikely that the vessel had struck a submerged object. Instead, a combined effect of previous groundings and subsequent repairs to its keel and matrix had possibly weakened the vessel's structure where the keel was attached to the hull. It is also possible that one or more keel bolts had deteriorated. A consequent loss of structural strength may have allowed movement of the keel which would have been exacerbated by increased transverse loading through sailing in worsening sea conditions.
