Giving exhaust problems the elbow

Ian Pirrie explains how to check the condition of the exhaust elbow on Yanmar GM engines

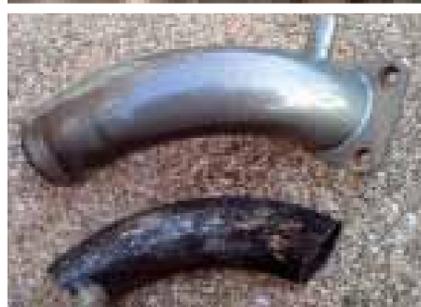
LEFT A concentric tube (bottom) is welded inside the outer tube, and is very prone to failure

Problems occur when hot exhaust gases are mixed with seawater: this is a very corrosive mixture. The elbow has a concentric tube welded inside the outer tube, which forms a water-cooled jacket around

the exhaust passage: this weld is very prone to failure.

Regular examination and replacement of the elbow is necessary to prevent major engine damage. Failure of the weld at the join of the inner and outer tubes can cause water to enter the engine through an open exhaust port and lead to hydro locking of the engine, which in turn can mean costly repair or replacement of the cylinder head and associated parts.

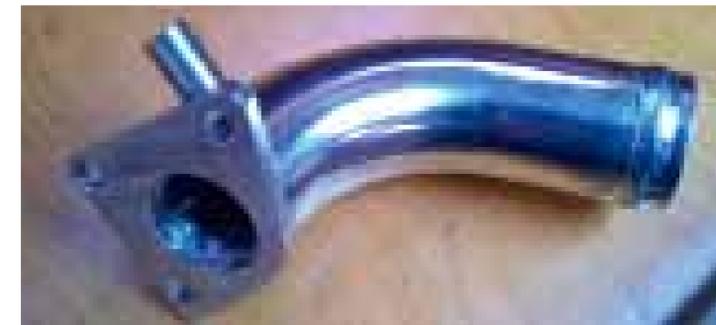
- 7 Under good light, clean all carbon deposits from the welded area. Some holes may be obvious, which will mean replacement of the elbow is required.
- 8 If it looks ok, hold the elbow with the engine side pointing down and fill the space between the inner and outer tube with water. If everything is as it should be, no water will be running out.

- 9 Having a general poke around the welded area with a small screwdriver will reveal any loose rusty sections and, depending on condition, replacement may be necessary.

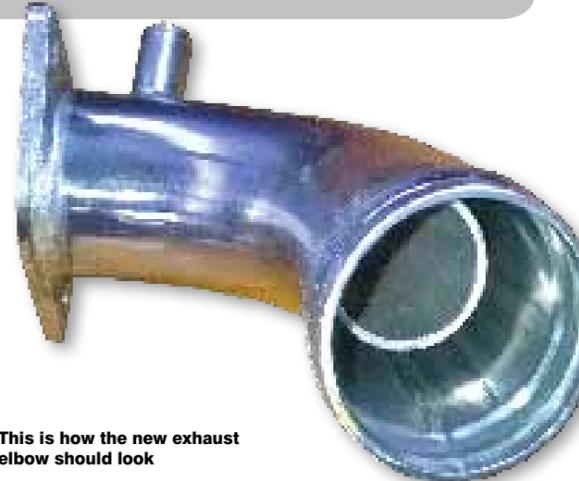
The new elbow was ordered online from the USA (www.exhaustelbow.com) and, including postage and customs, cost just less than half the price of the Yanmar part from a UK dealer. The new elbow, although not a Yanmar part, is made of stainless steel and looks and feels of very good quality

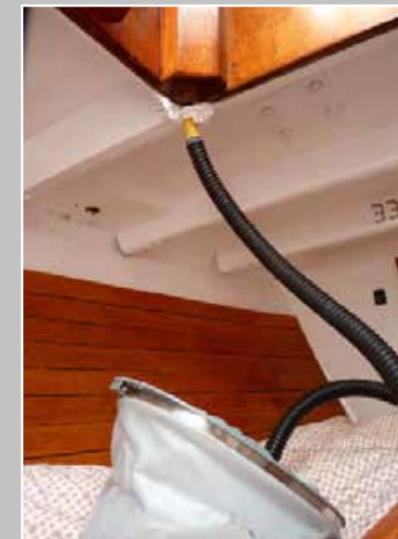
Attach the pipe from your dinghy inflation pump pipe to the point where the drip emerges. This can be done by sundry means such as duct tape, plasticine or some putty-like substance. Alternatively, connect a soft piece of hose to the inflation pipe and manually press the other end onto the leak. The connection doesn't have to be airtight, simply capable of providing some pressurisation. Wet the deck with soapy water, and start using the pump: bubbles will appear on deck at the leak's source. Repair as appropriate to the deck's construction.

Your dinghy inflation pump can be used to trace the point of origin of deck leaks

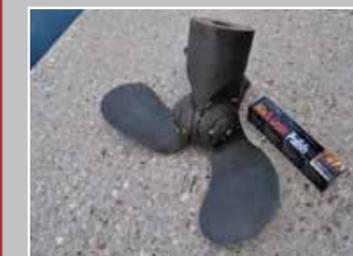
This prop came off a friend's boat that had been in the water for four months, cruising the English Channel and Brittany. When it went in the water the clean and polished prop had been treated with Stovax Black Grate Polish. The result was not bad at all for a season which saw a lot of serious fouling, and the polish is super value at £4 for a 75ml tube.
